# ENVIRONMENT COMMITTEE AGENDA

# MEMO

## 1.0 EXISTING CONDITIONS

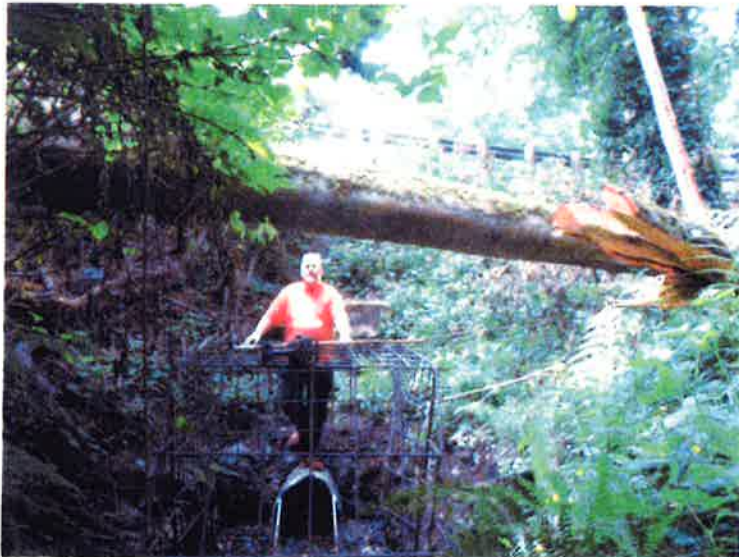
Photo 1 – Existing Culvert Entrance

The existing culvert is estimated as 80 to 90 feet long 24-inch diameter vitrified clay pipe with a 60-inch catch basin with a grated top and about 10 feet of 24-inch diameter corrugated metal pipe extension on the upstream end. The upstream end of the culvert is protected by a rebar cage to prevent large debris from entering/blocking the culvert entrance, see Photo 1.

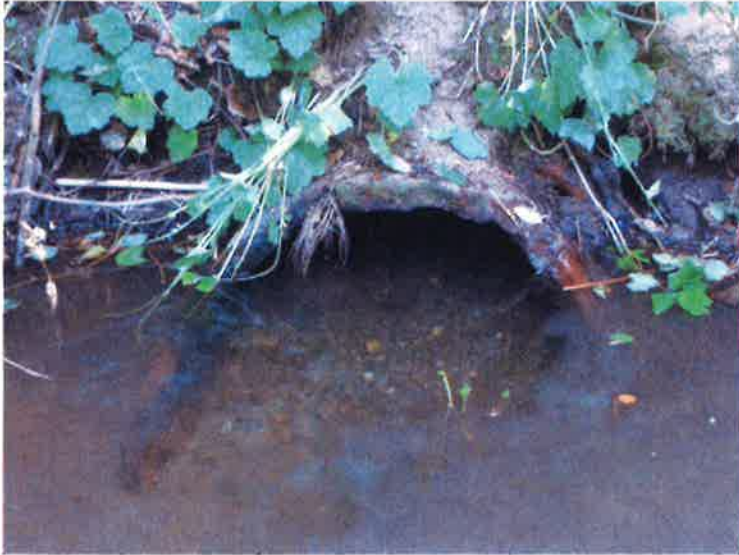
Photo 2 – Existing Culvert Outlet

The culvert exit protrudes from the road embankment. The outlet is backwatered from a large downstream sediment bar that is at or a few inches higher than the top of the culvert at the downstream end. Photo 2 shows the outlet with the backwater and sediment accumulation of about one-half the culvert diameter (prior to cleaning).

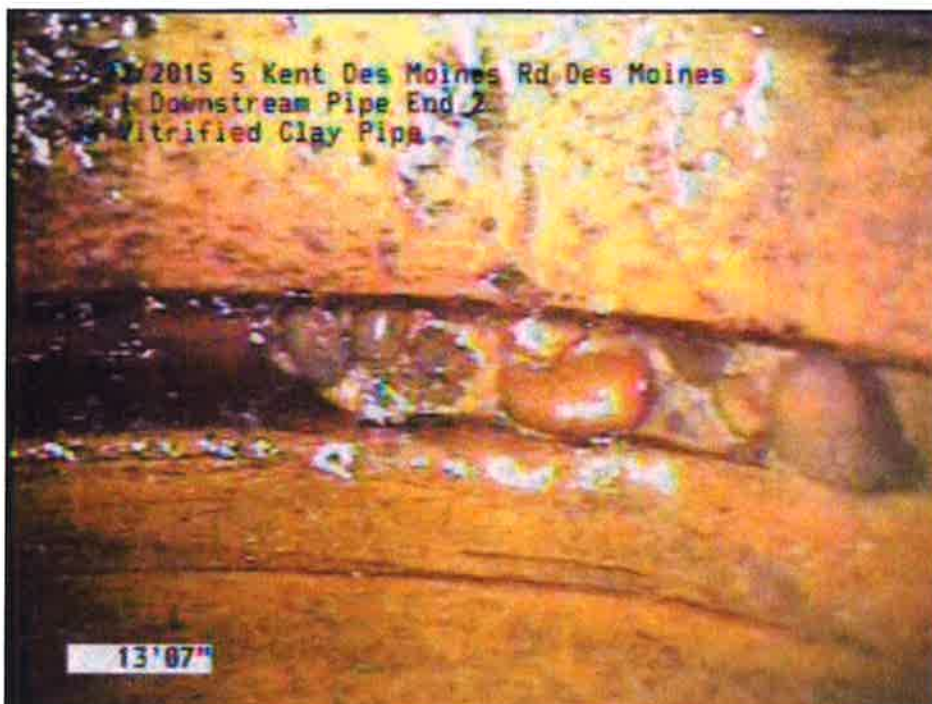
- Separated joints (see Photo 3)
- Fractured pipe segments (see Photo 4)
- Displaced fractured pipe segments (see Photo 5)
- Missing pipe piece on invert (soil visible) (see Photo 6)
- Extensive root penetrations along pipe joints (see Photo 7)

Photo 3 – Separated Joints

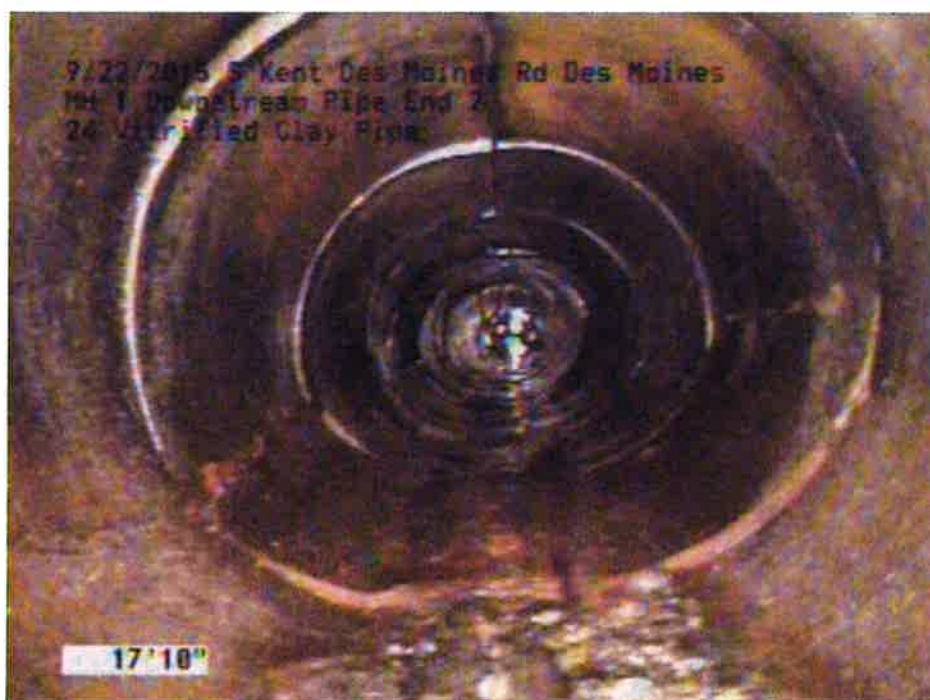
Photo 4 – Fractured Pipe Segments

The structural integrity of the culvert has failed as seen by the cracked and displaced culvert barrel. The severity of the cracking created the "critical" classification. Had the cracking not caused displacement of pieces of the broken culvert and a missing piece from the culvert invert, a "poor" classification would have resulted. As there is no structural integrity in the cracked culvert material itself to maintain the round culvert opening, the surrounding backfill is maintaining the current shape. Should a large segment of broken culvert become dislodged to expose the backfill material, the backfill will likely fall into the culvert and either be washed downstream or block the culvert. Depending upon the rate of backfill falling into the culvert and the degree of blockage, a void above the culvert will occur. This will lead ultimately to caving from the surface and road failure.

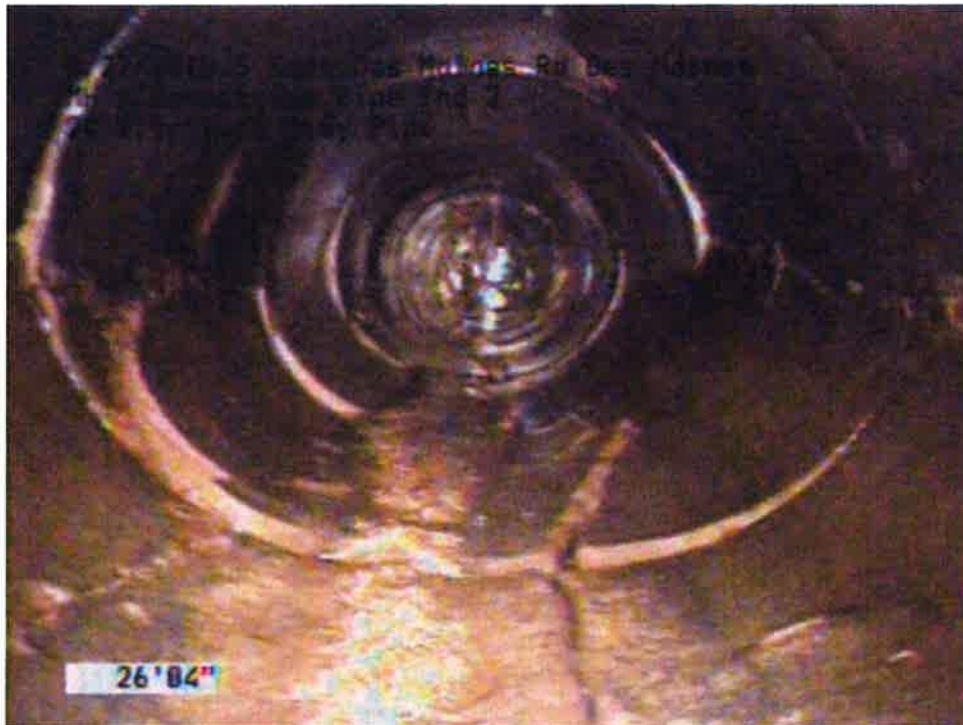
Photo 5 – Displaced Fractured Pipe Segments

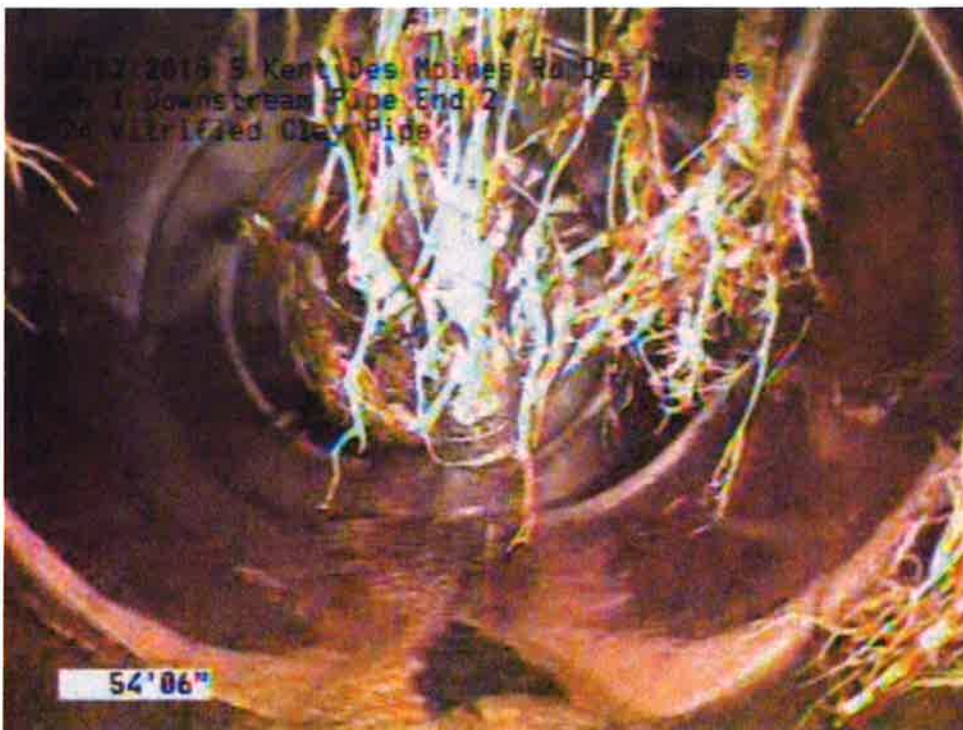
Photo 6 – Missing Segment of Pipe on Invert and Root Intrusion

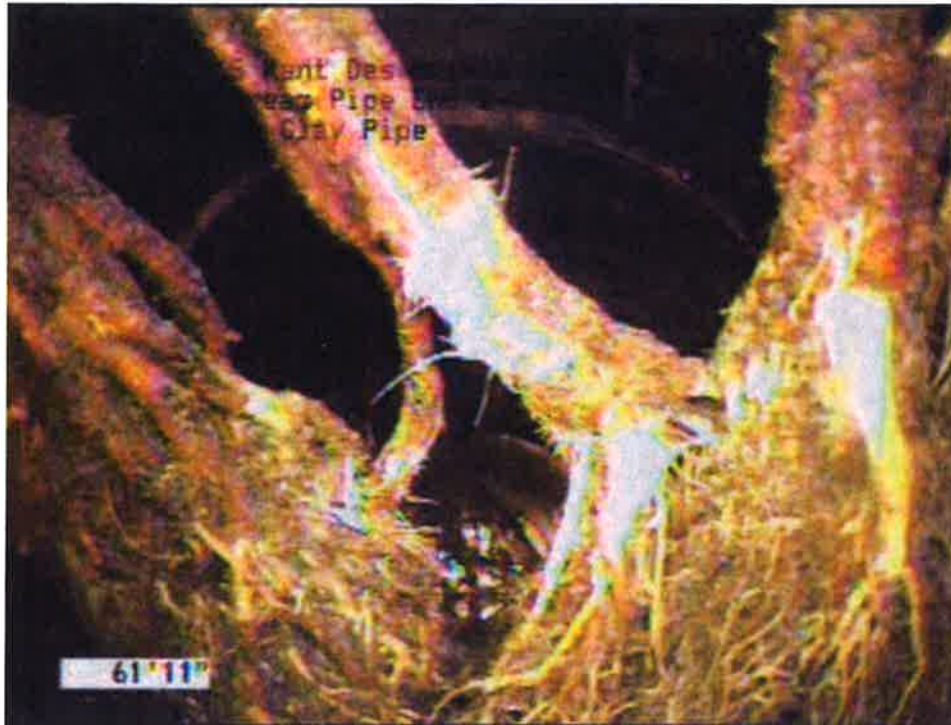
Photo 7 – Extensive Root Penetrations (outlet of culvert visible in the background)

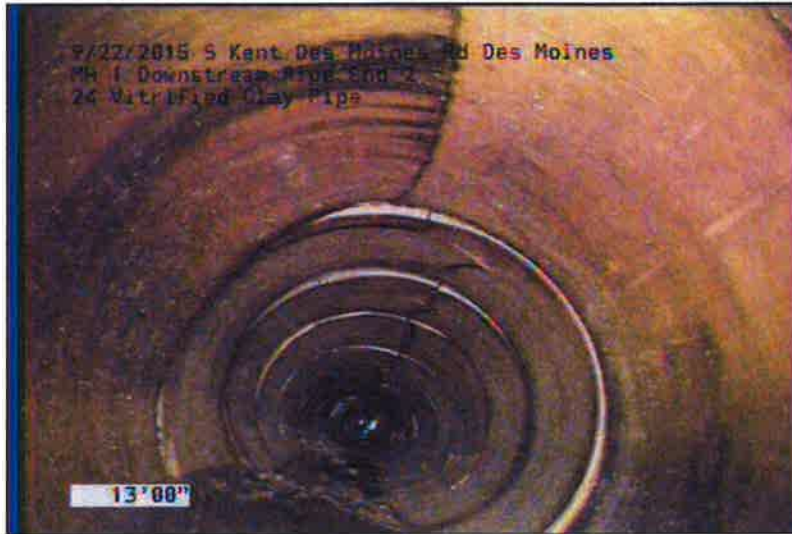
Photo: NA\_MH 1\_Pipe End 2\_S Kent Des Moines Rd\_22092015\_130536\_A.JPG, VCR No.: 9.22.2015  
 13.6FT, Fracture Longitudinal, at 11 o'clock, within 8 inches of joint: YES

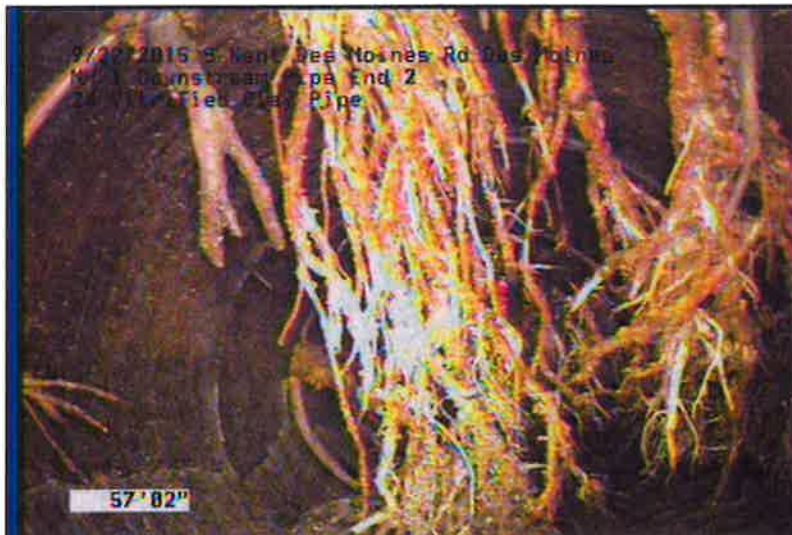
Photo: NA\_MH 1\_Pipe End 2\_S Kent Des Moines Rd\_22092015\_131651\_A.JPG, VCR No.: 9.22.2015  
 50.2FT, Roots Tap Joint, from 10 to 02 o'clock, 20 %, within 8 inches of joint: YESR, Start

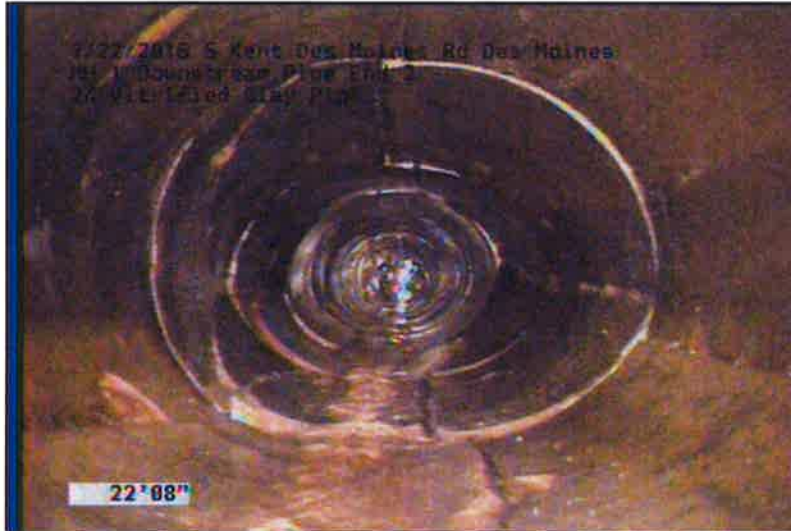
Photo: NA\_MH 1\_Pipe End 2\_S Kent Des Moines Rd\_22092015\_145203\_A.JPG, VCR  
 No.: 9.22.2015  
 20.4FT, Fracture Longitudinal Hinge, 4, from 12 to 12 o'clock, within 8 inches of joint:  
 YES, Start

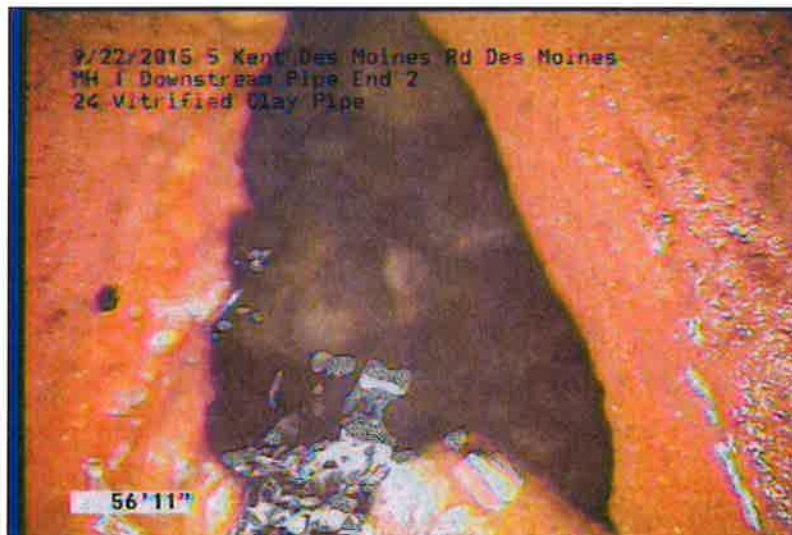
Photo: NA\_MH 1\_Pipe End 2\_S Kent Des Moines Rd\_22092015\_145507\_A.JPG, VCR  
 No.: 9.22.2015  
 56.95FT, Hole Soil Visible, from 05 to 06 o'clock, within 8 inches of joint: YES
